BROWN'S LAKE DAM

NDI ID NO. PA-00630
DER ID NO. 45-108

PHASE I INSPECTION REPORT
NATIONAL DAM INSPECTION PROGRAM

JUNE 1980

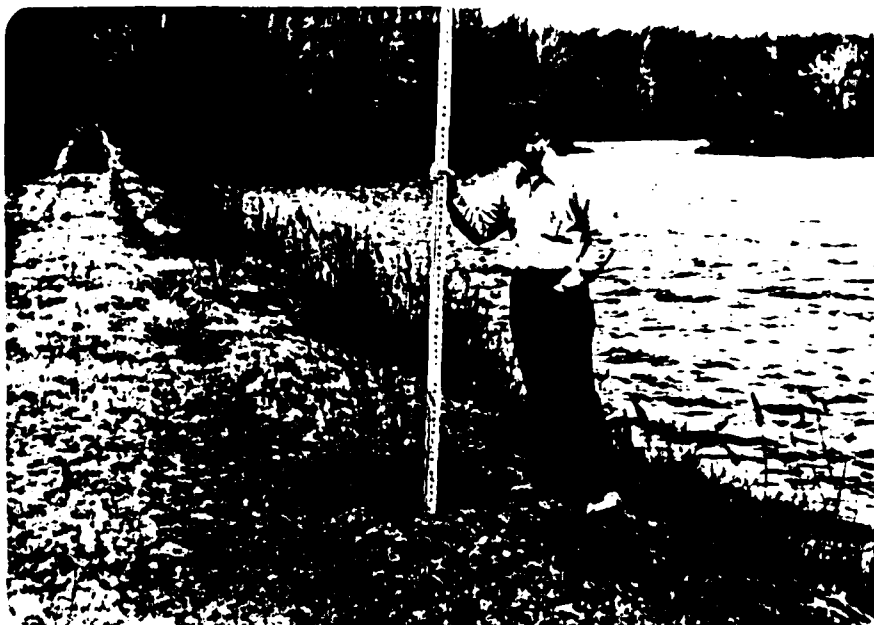
The depression on the top of the dam indicates that potentially hazardous conditions might exist within the embankment. The caretaker stated that the depression developed about 5 years ago, and that it has not increased in size since then. The most likely explanation for the depression is that piping of the upstream earthfill into the downstream rockfill was initiated by seepage through or over the timber corewall. It is not known whether the pool level was above normal when the depression developed. The piping, if it occurred, probably stopped either by a self-healing process or by a return to normal pool level.

B. Depression on Top of Dam.

(1) Perform detailed investigations as required to assess the stability of the dam. The investigations should include assessment of seepage conditions and piping potential. Take appropriate action as required.

(2) Until the investigations recommended above are complete, the Owner should institute a monitoring program to detect any significant change in the condition of the dam. If conditions change, take appropriate action as required.

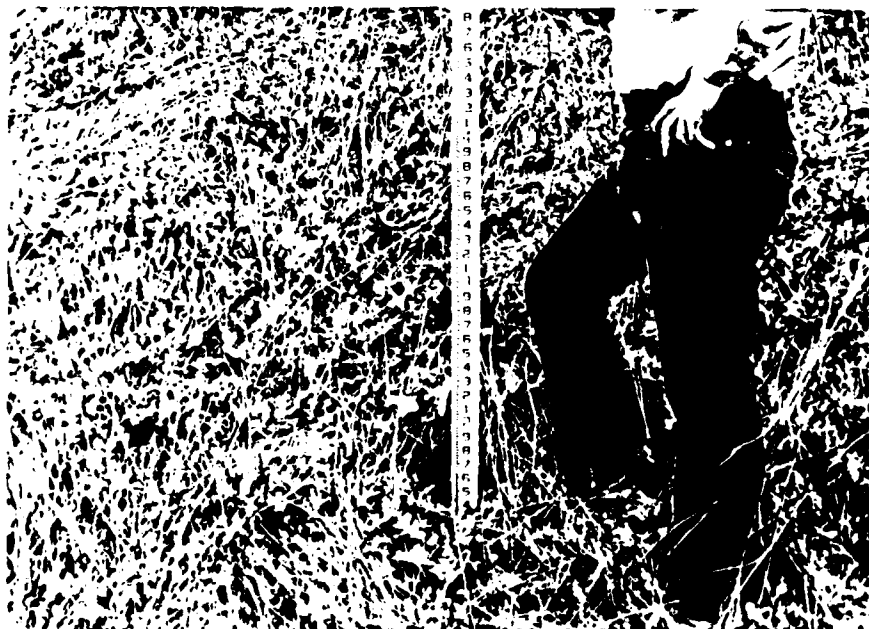
The 4 holes and the depression on the downstream slope are of concern. The caretaker stated that he was unaware of the holes. One of the holes might have resulted from deterioration of a tree stump, as indicated by rotted wood fragments in the hole. The origin of the other holes is less certain. There were no signs that the holes were created by animals. One possible cause of the holes and the depression might be migration of overlying earthfill into the underlying rockfill. The records indicate that no filter material was placed between the fine and coarse materials.

F. Hole on Downstream Slope.

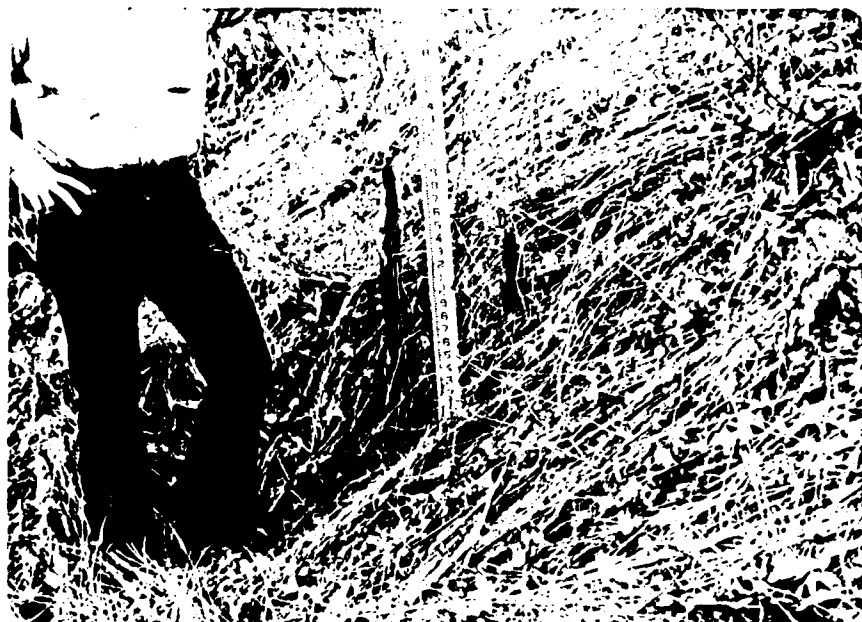
G. Depression on Downstream Slope.

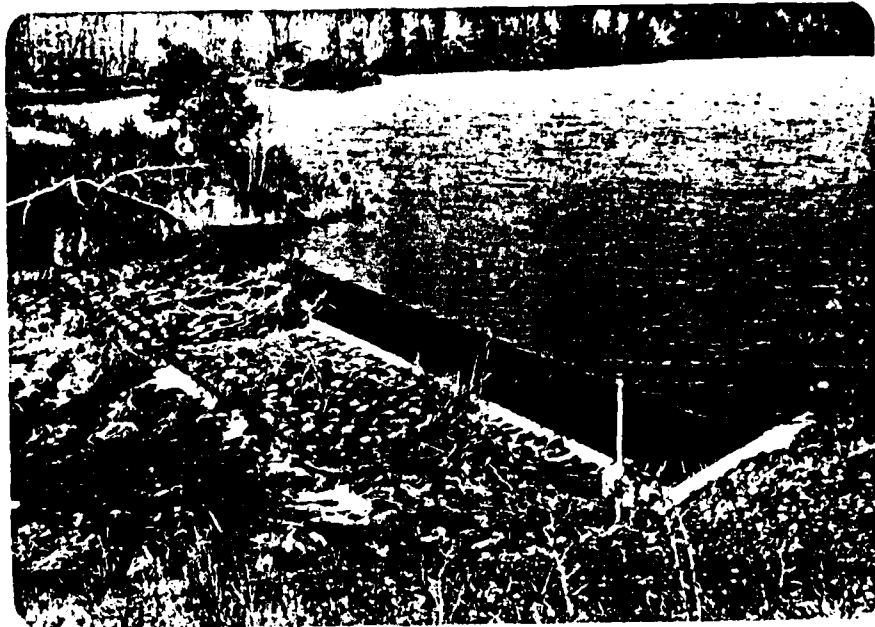
c. Appurtenant Structures. The spillway is in fair condition (Photograph I). The left abutment wall has a slight, inward tilt, two cracks, and minor spalling at its base adjacent to the spillway weir. The spillway weir is a low, triangular, concrete weir. A concrete apron extends downstream from the weir for a distance of about 10 feet. Some debris was on the spillway on the day of the inspection. The weir has two areas where the concrete has cracked and spalled. Both areas are near the right end of the weir. The right abutment wall has trees and brush growing behind it. The spillway outlet channel is an excavated earthen channel (Photograph J). It appears that the channel has been subject to retrogressive erosion.

(3) Appurtenant Structures. The cracking, spalling, and slight inward tilt of the left spillway wall do not appear to be significant hazards at the present time. Even if the left wall were to fail, failure of the dam would not necessarily occur. The condition of the spillway outlet channel is such that retrogressive erosion might eventually endanger the spillway structures.

I. Spillway.

(6) Remove debris from the spillway and visually monitor the condition of the spillway structures. Maintain the structures as required.
